An Examination of Home Destruction

Roaring Lion Fire Bitterroot Mountains, Montana

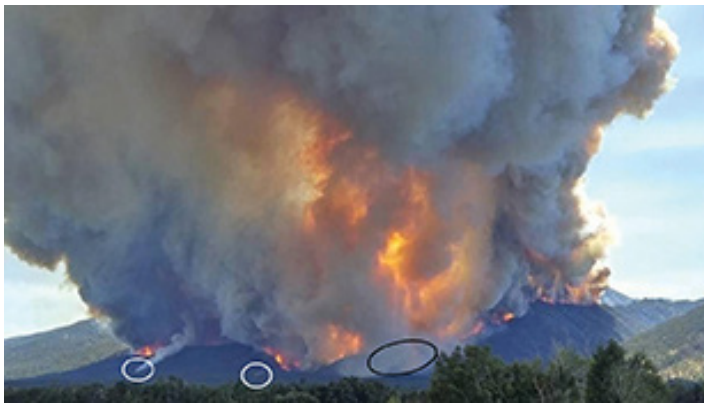
Figure 1. This is the Roaring Lion Fire on July 31 as it spreads eastward and down slope to approach the residential areas near the base of the slope. Significant sections of the flaming front is high intensity crown fire and showering an area downwind with firebrands. The white ovals identify firebrand ignited spot-fires. The black oval identifies an area of down draft that rapidly resulted in spreading spot-fires seen after the smoke cleared.

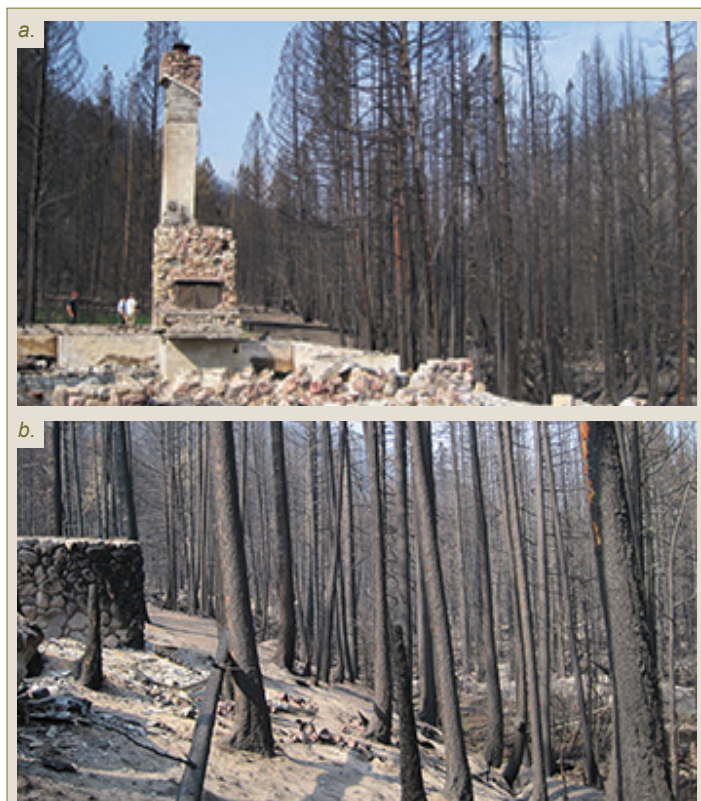
Figure 2. ACTIVE CROWN FIRE. These two separate but associated houses, a) and b) were several hundred feet apart. Both of these structures were 30 feet or closer to active crown fire.

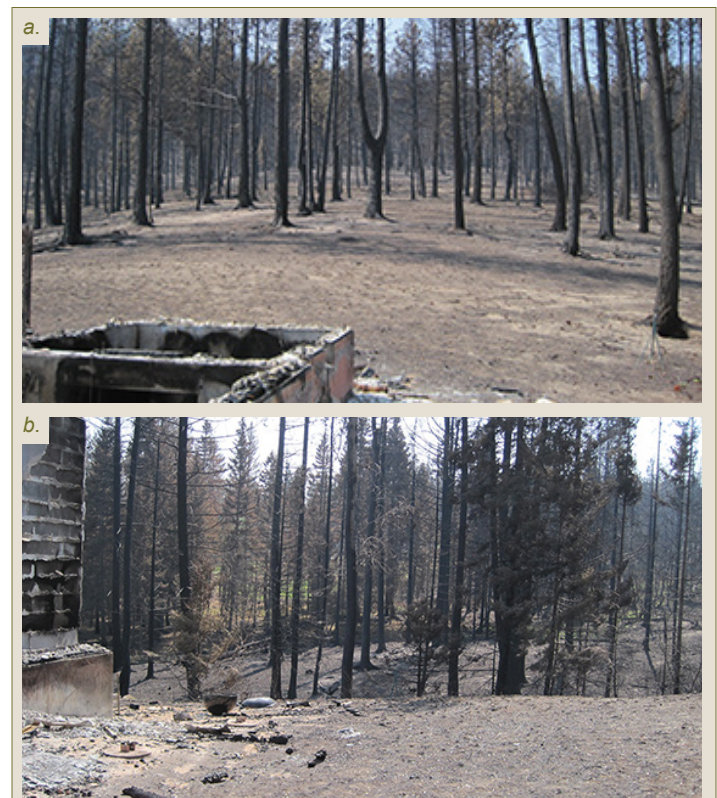
Figure 3. PASSIVE CROWN FIRE. Photos a) and b) are two different views from the same house. The incomplete canopy consumption indicates individual tree torching with brief passive crown fire in the background. The house was more than 60 feet from high intensity burning but note the complete consumption of continuous surface fuels leading to the house.

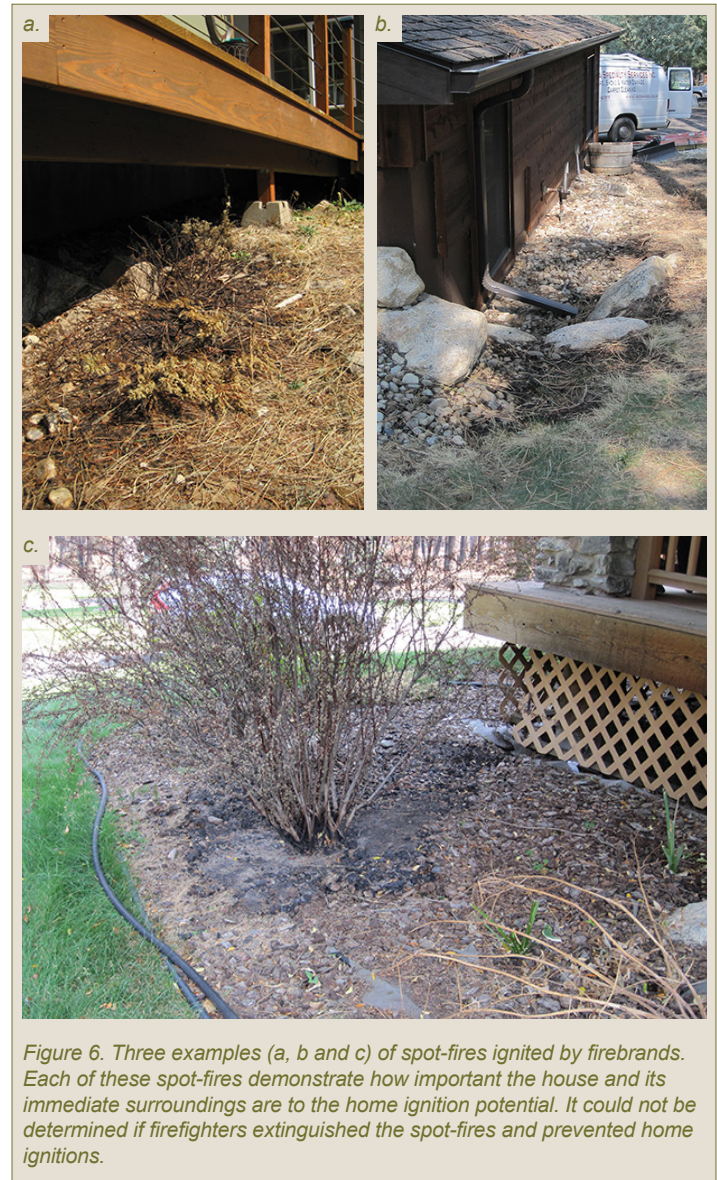
Determining firebrand ignitions of destroyed and damaged structures can be less obvious. Figures 7 and 8 provide examples of two different structures that ignited from firebrands. One could not be protected and free burned to total destruction (Figure 7) and the other damaged but not destroyed due to successful follow-up firefighter protection (Figure 8). These examples show how common observer perceptions of extreme wildfires as an all-consuming wall of flames belie how homes ignite and burn to total destruction.

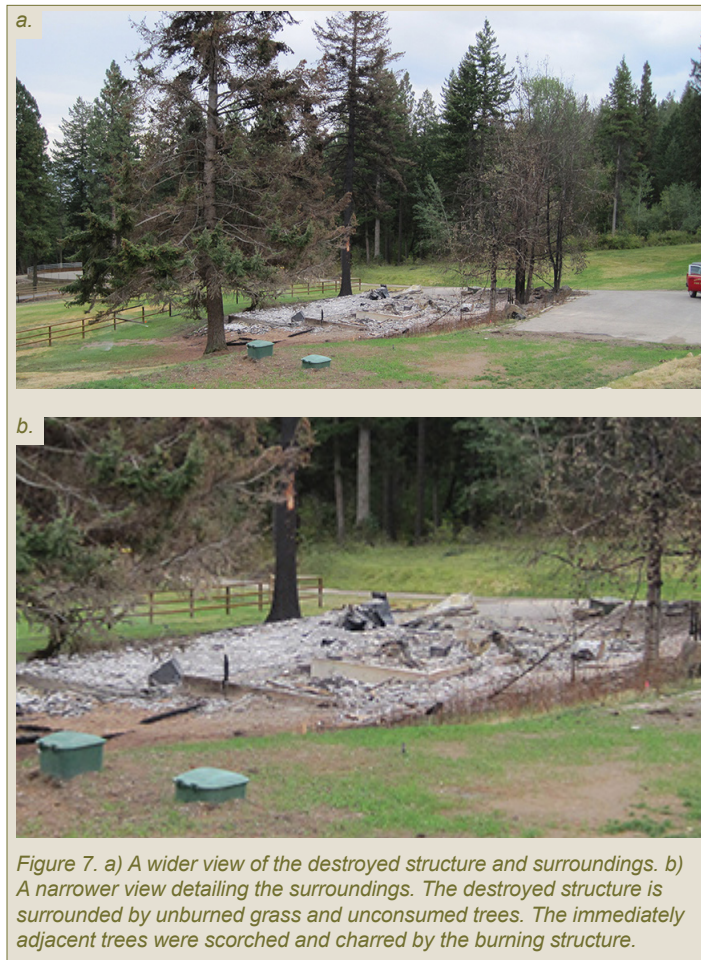
The destroyed structure in Figure 7 was located in an irrigated meadow with fuel treatment in parts of the adjacent forested area. Unconsumed vegetation surrounded the destroyed structure without evidence of fire spreading to the structure; the adjacent scorched and charred trees were due to the burning structure. The total lack of wildfire flame exposure immediately surrounding the destruction indicated a firebrand ignition source. This conclusion was supported by an active crown fire within ¼ mile and up wind of the destroyed structure.
